Manhole Inspection Summary

Manhole # S11II_001MH

Location Address: **REAR 1801 ROSEDALE ST**

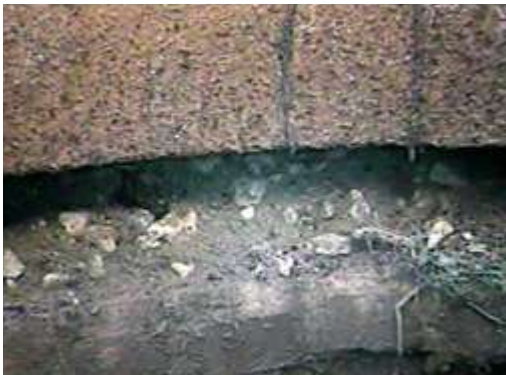
Defect 2

Chimney / Frame Adjustment ☒ Exists Material: **Brick and Concrete** ☐ Parged Height: **3** (in.)

Condition: ☐ Sound ☐ Cracked ☐ Root Intrusion ☐ Loose Brick ☒ **Deteriorated**

DETERIORATED ADJ.

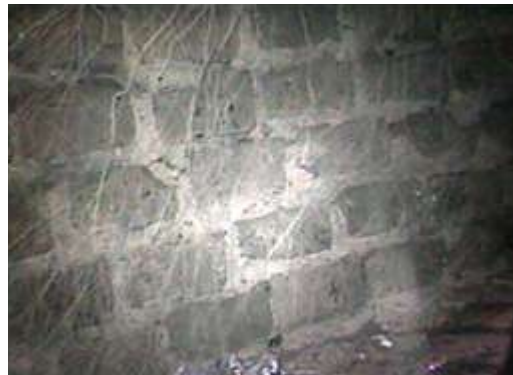
Defect 1

Condition: ☐ Sound ☐ Cracked ☒ **Root Intrusion** ☐ Loose Brick ☐ Deteriorated

Infiltration: ☐ None ☐ Joint ☐ Cracks ☐ Mortar ☒ **Roots** ☐ Wall

ROOT INFILTRATION - FINE ON
CORBEL AND BARREL

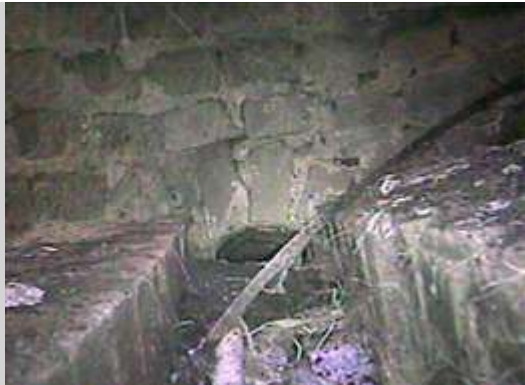
6 O'Clock Inflow

6 in. Circular Gravity Sewer
Pipe In @ 6 O'Clock

Deposits: ☐ None ☐ Mud ☐ Sludge ☒ **Debris** ☐ Grease

Silt Depth: **3** (in.) Deposits Extent: **Medium**
